COUNTY GOVERNMENT OF BOMET
BOMET MUNICIPALITY
P.O. Box 19-220400 BOMET, KENYA
10 SEP 2021

Introduction

Silibwet Town, and most especially Hot Wax Hotel Street has no detailed design of stormwater drains carried out by engineers also climatic and hydrological data was not taken into account from the initial design.

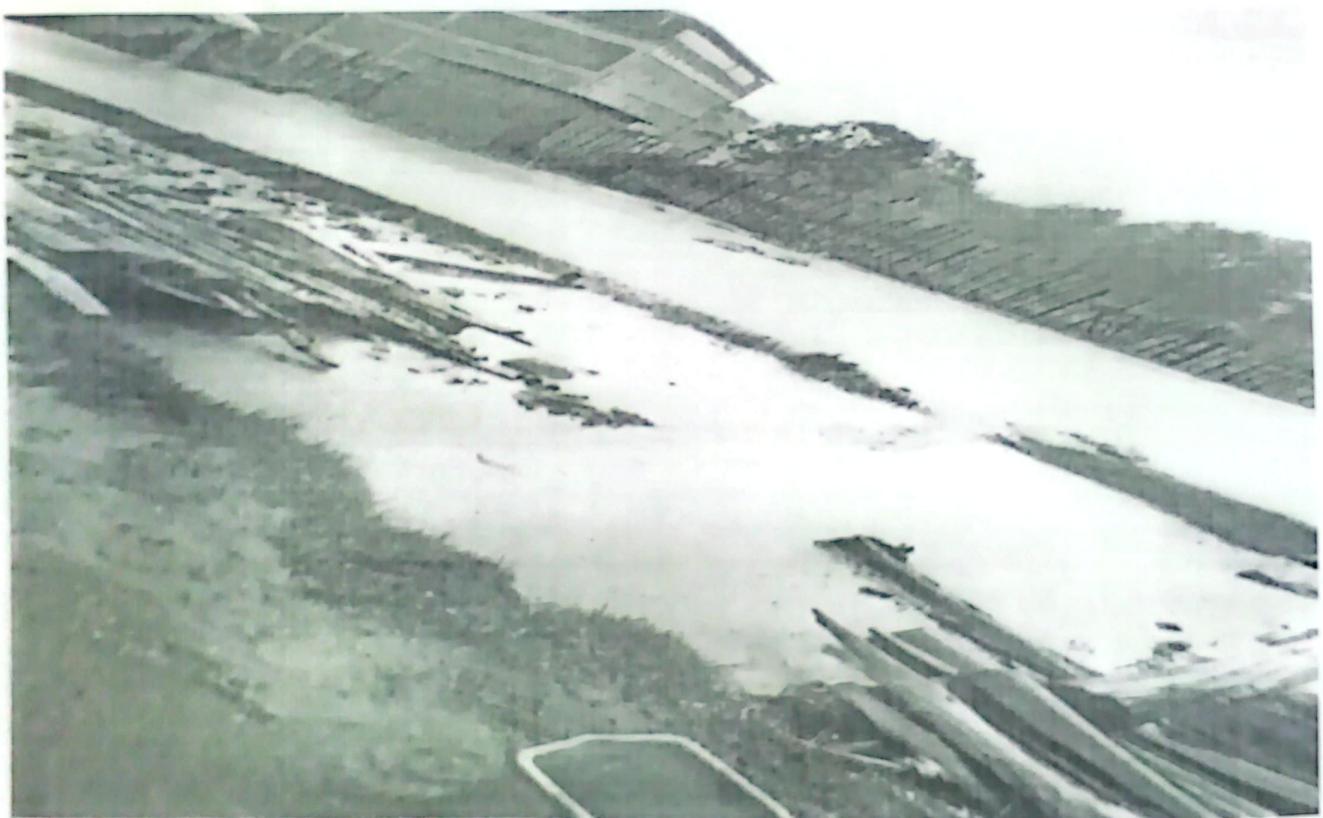
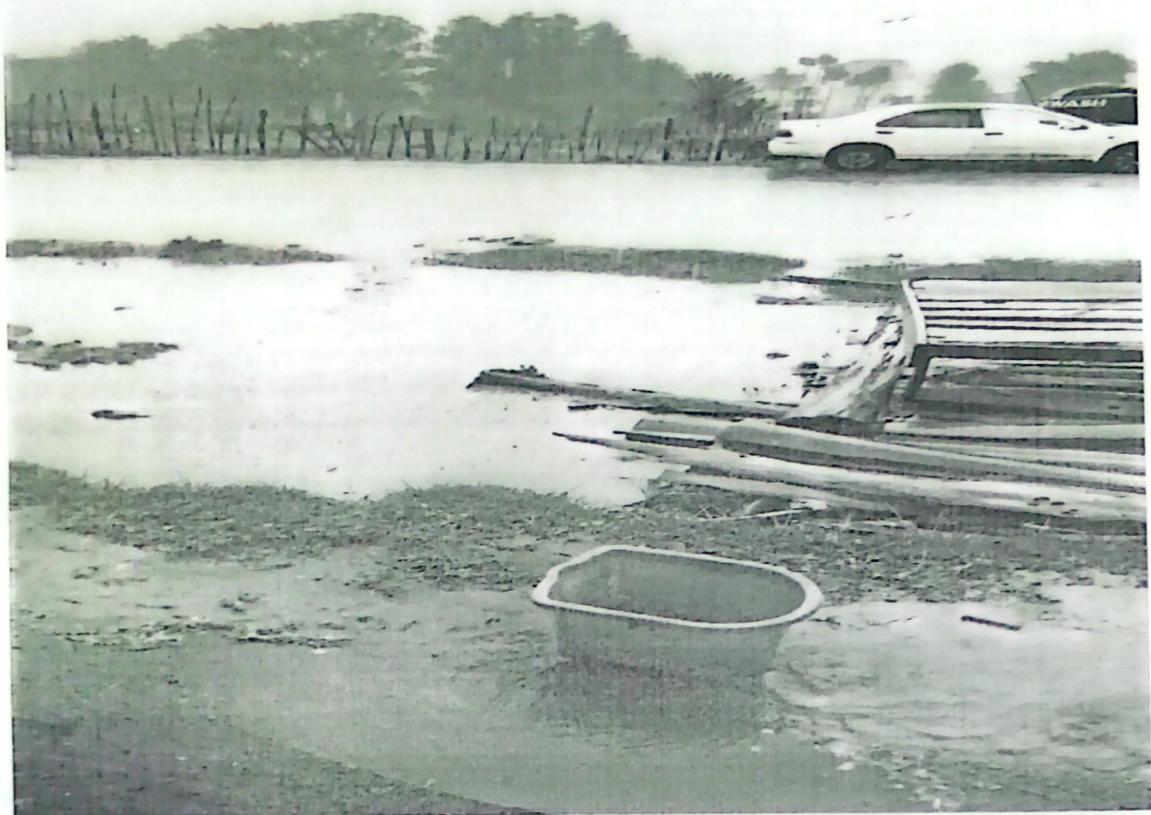
Previous Floods

Business and plot owners were able to describe areas where major flood problems occur in the town and helped in providing information about previous floods, some of which are best described in pictures attached.

Attached are pictures showing previous flood in the very same area where complain has been raised:

Redesigning and constructing drainage systems require expert advice from engineers to make sure that water flows away quickly and smoothly and is disposed of in a surface watercourse or soakaway.

This can be done by installing Culvates across the tarmiac road, passing through the road reserve to avoid creating problems with plot owners and the communities downstream nor should it affect ecologically important sites.

- 1) Proactive measures should be taken to reduce and manage flooding hazards (like clearing of drains before rain season begins).
- 2) Improvement on the integration of road and urban storm water drainage infrastructure.
- 3) Integrated solid waste management.
- 4) Urban storm water drainage infrastructure should be contracted with road infrastructure.
- 5) Encourage site infiltration through: Permeable pavements like porous concrete, coble stone, vegetated structures or grassing on road sides and vacant spaces/ gardens.
- 6) Ensure sustainable urban drainage management, there should be an integrated urban storm water drainage management on stand by especially during Elnino period.

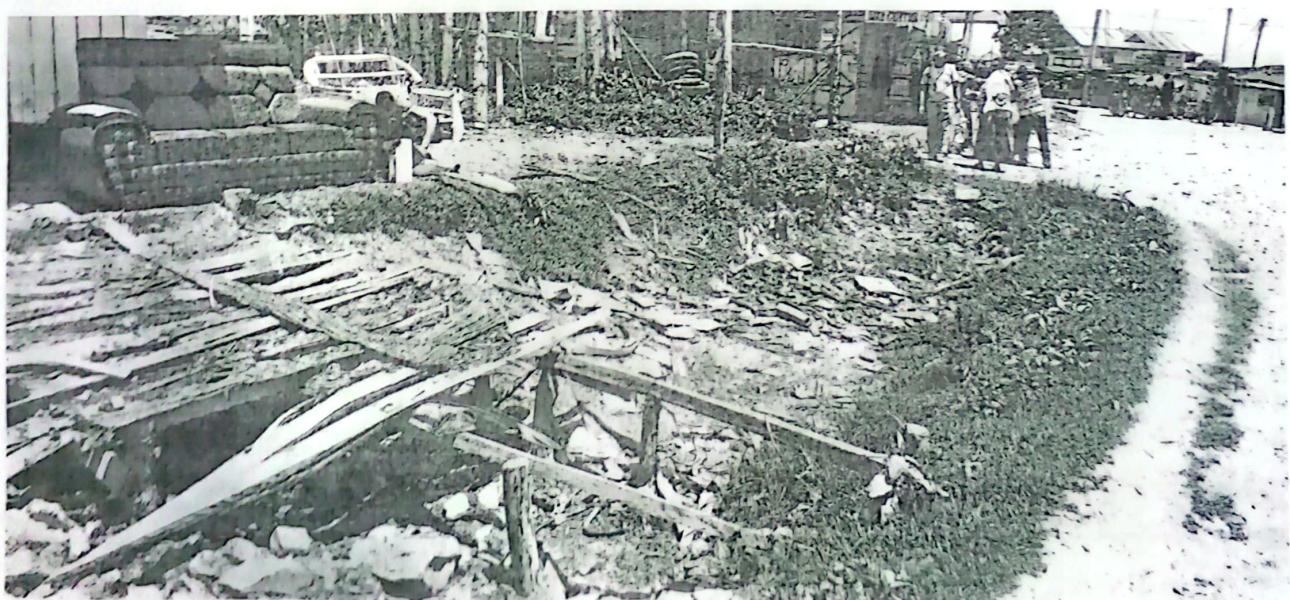
Blocked Drainages

- 1) Silibwet has Inadequate integration between road and urban storm water drainage lines followed by blockage of drains by solid wastes are the major causes of flooding in the area.

- 2) Sewerage connection and solid waste dumping reduce the effective carrying capacity of drains.
- 3) To safely discharge the flood generated within the area the urban storm water drainage facilities should be revised and designed .
- 4) Urban storm water drainage facilities should be contracted with roads for timely accomplishing and good workmanship.

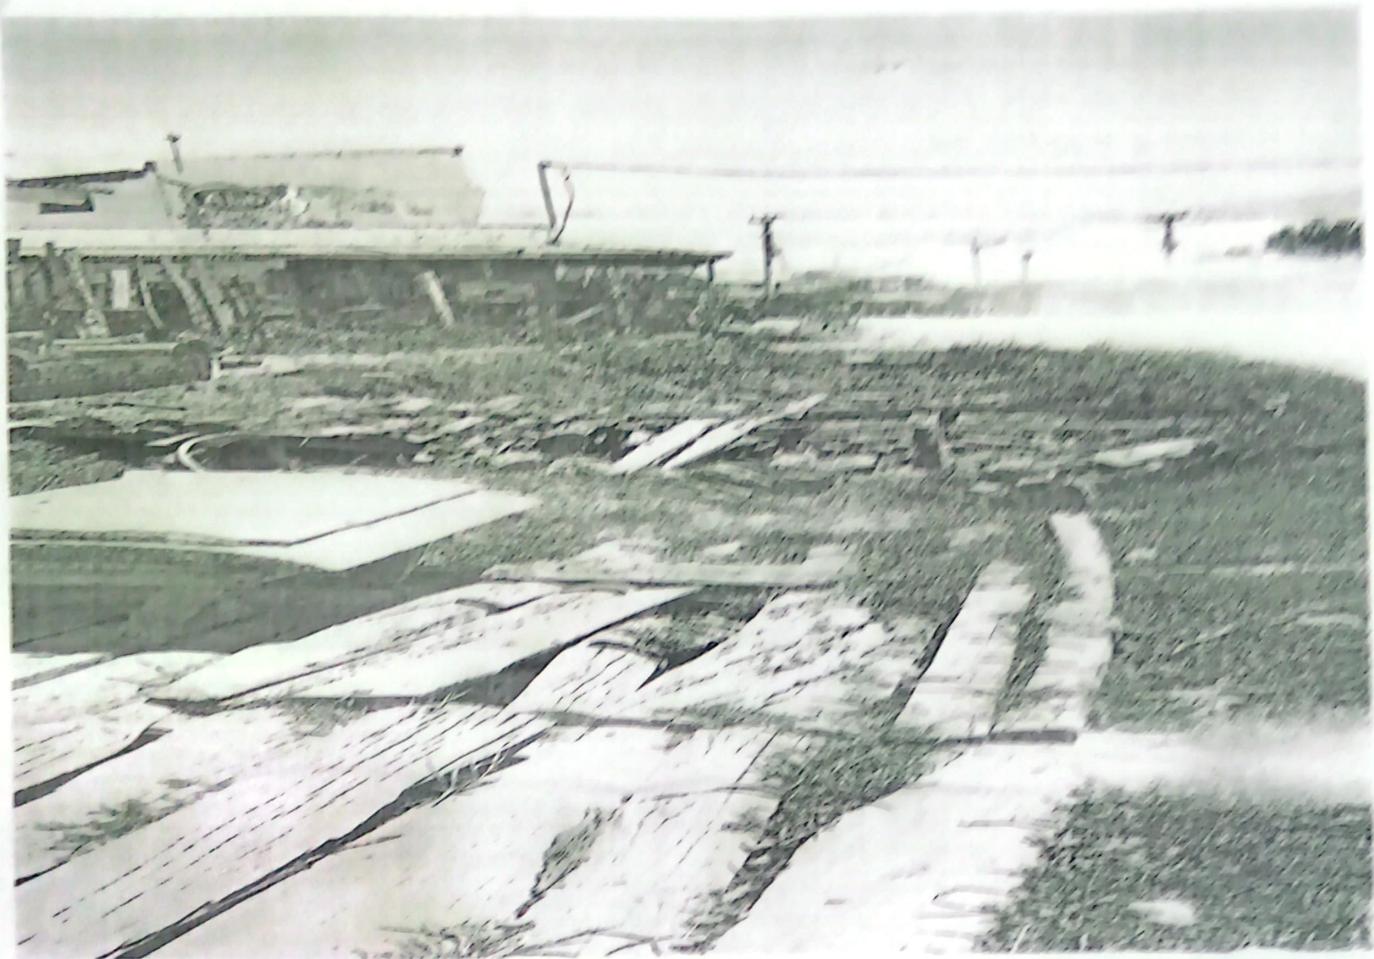
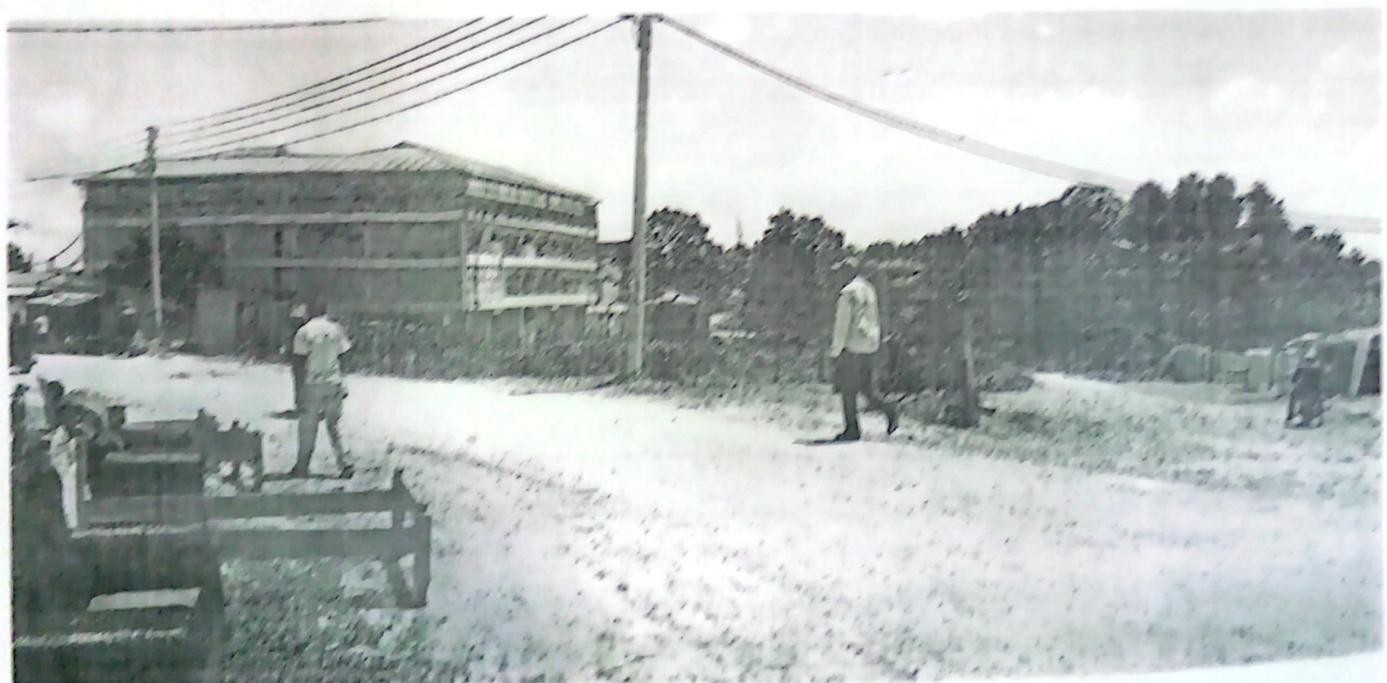
Business/Capentry works operating in an already blocked drainage
